Additional test report

Comparative test on fire behaviour of flat roof waterproofing systems with different thermal insulation materials and equipped with identical photovoltaic systems

0151-L-20/4

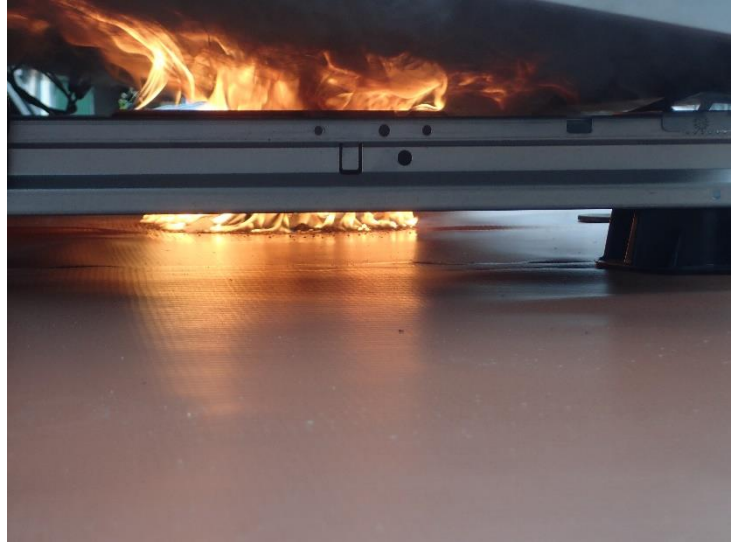
Photo 7
The roofing and PV module
are burning (time 10:11).

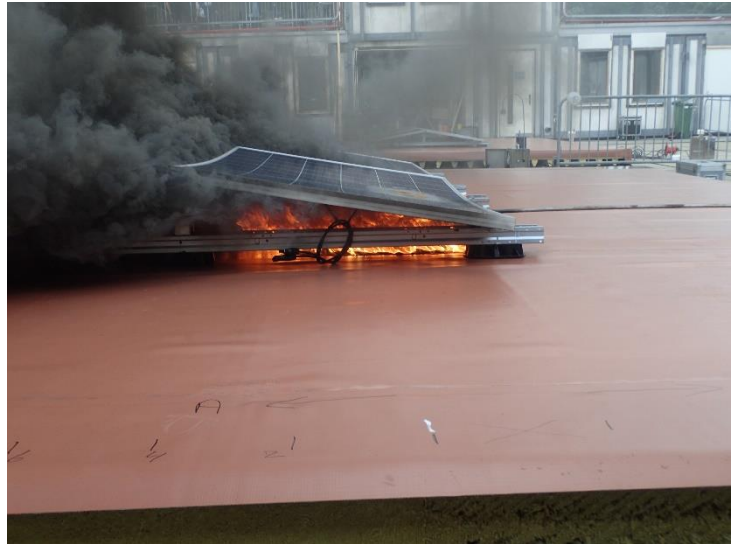
Photo 8
The fire is spreading
underneath the PV modules
(time 10:13).

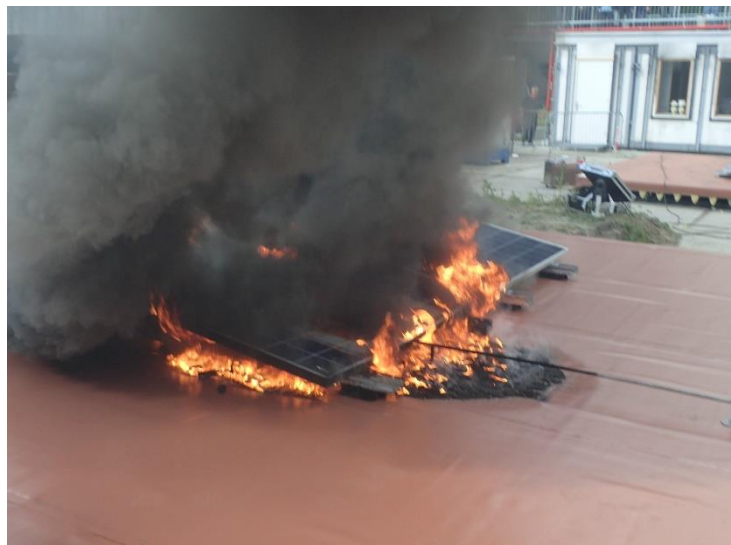
Photo 9
The fire is spreading
backwards outside the
PV modules (time 10:14).

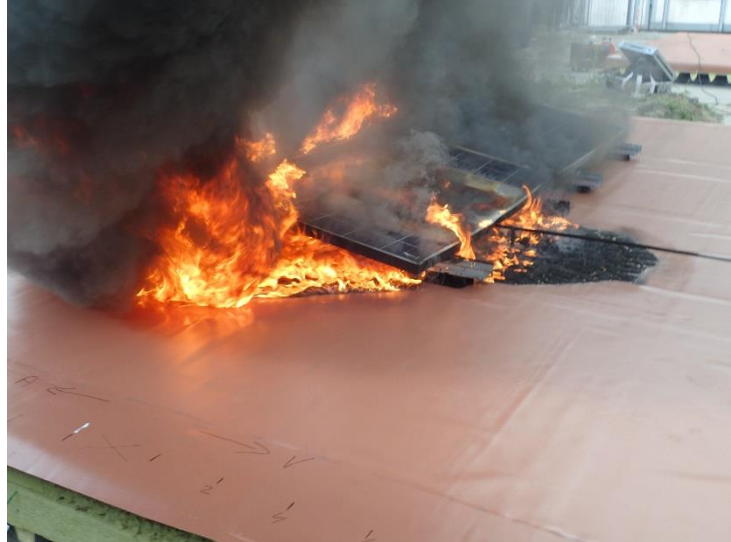
Photo 10

The fire is spreading on the left side outside the PV modules (time 10:15).

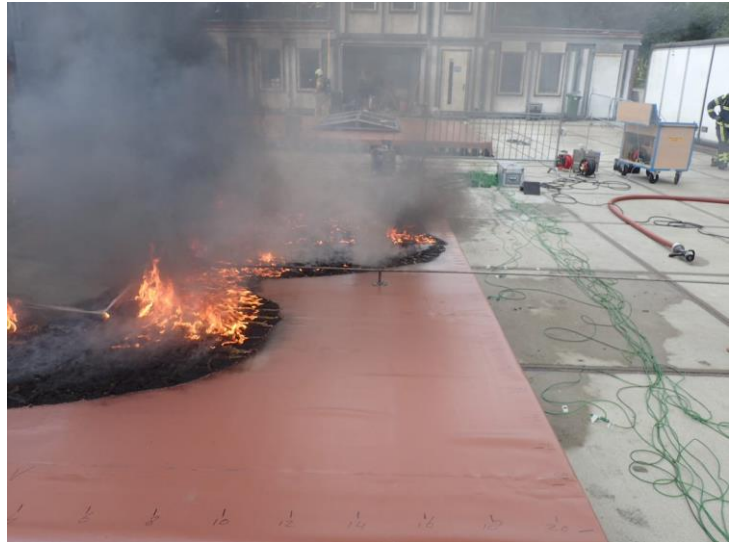
Photo 11

The fire is spreading backwards again outside the PV modules (time 10:19).

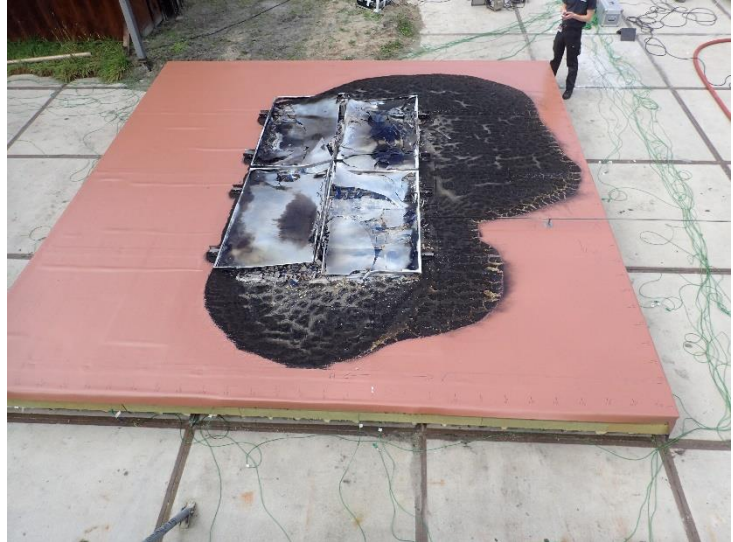
Description	Results	
	System A (MW)	System B (PIR)
External fire spread / burnt length ¹⁾		
▪ left	1735 mm	925 mm
▪ right	3255 mm	3695 mm
▪ forward	1795 mm	2485 mm
▪ backward	2045 mm	1515 mm

Photo 13
Overview of the burnt roof
waterproofing sheet including
PV modules.

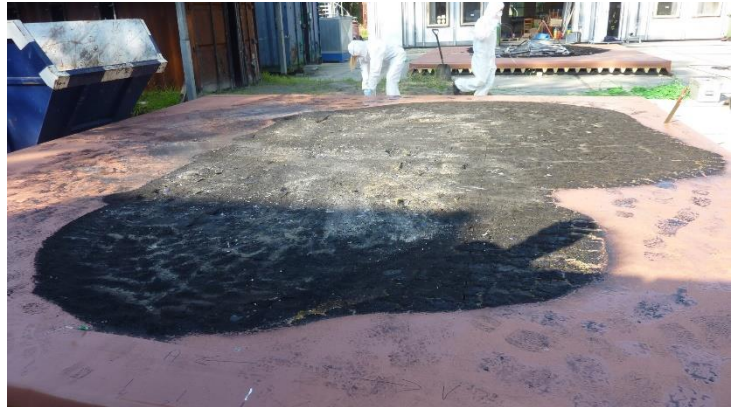
Photo 14
Overview of the burnt roof
waterproofing sheet.

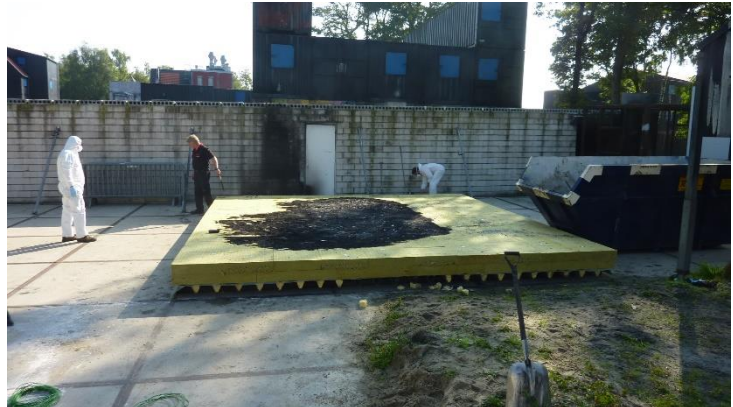
In test specimen A (MW) the fire has gone out after 28:35 (min:s). After 30 minutes the temperature has reached 35 °C in the middle of the insulation. After approximately 4 hours the temperature has reached 440 °C in the middle of the insulation and is still increasing slowly. Overnight measurements on the steel deck showed a peak temperature of 190 °C.

Photo 15
Overview of the burnt section
of the MW insulation
(top layer).

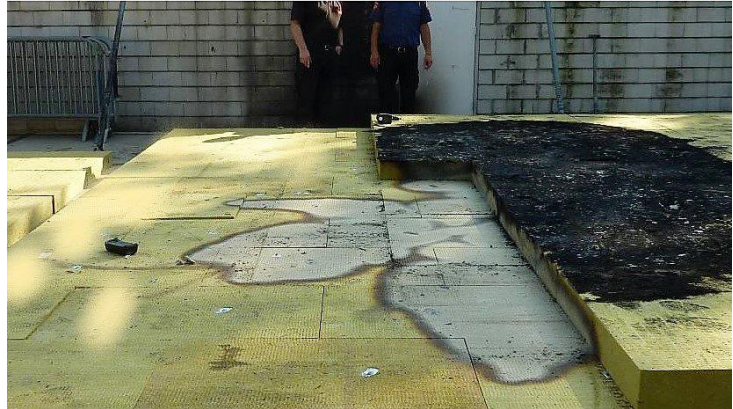
Photo 16
Overview of the burnt section
of the MW insulation
(top layer and underlayer).

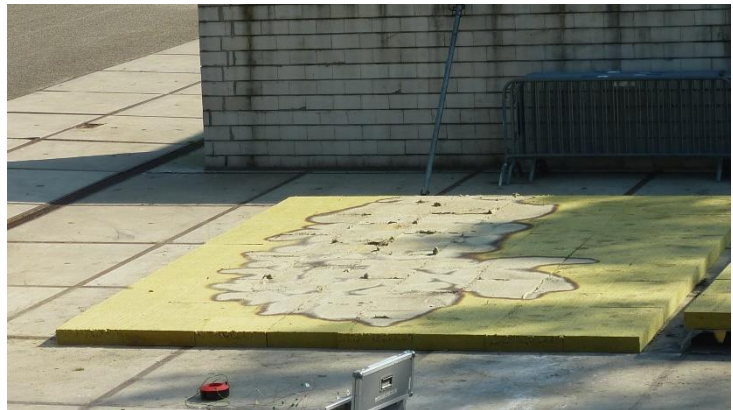
Photo 17
Overview of the burnt section
of the MW insulation
(underside of top layer).

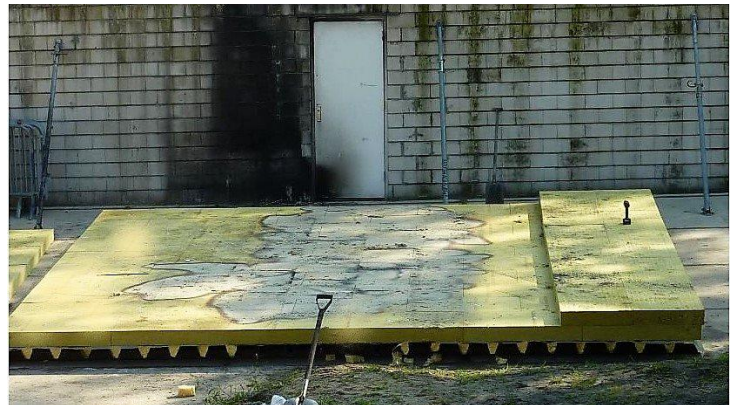
Photo 18
Overview of the burnt section
of the MW insulation
(underlayer).

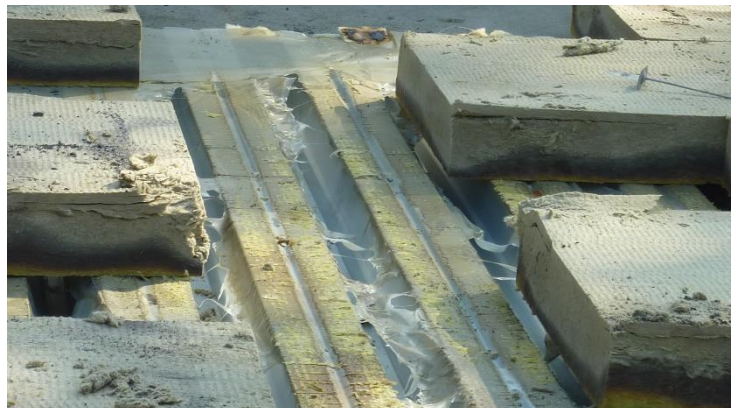
Photo 19
Detail of the burned vapour
barrier.

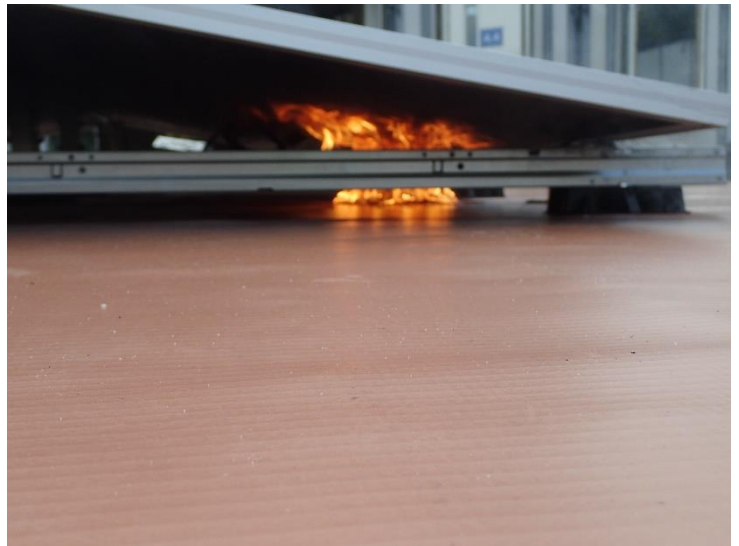
Photo 27
The roofing and PV module are burning (time 15:04).

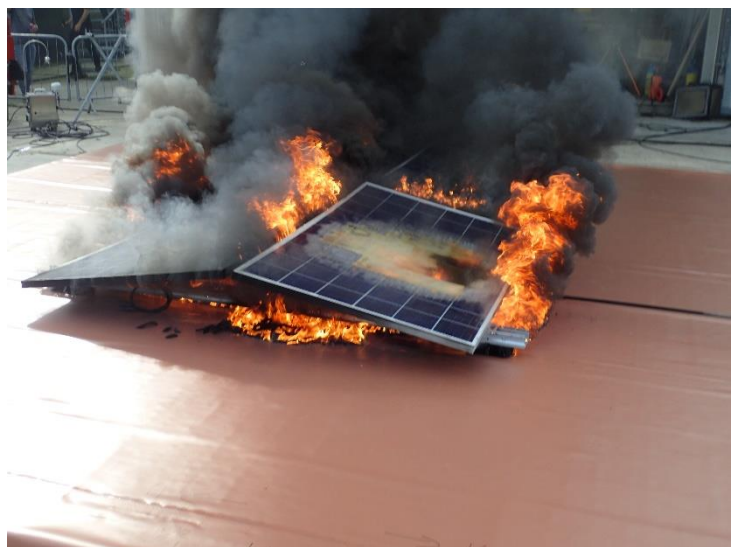
Photo 28
The fire is spreading underneath the PV modules (time 15:06).

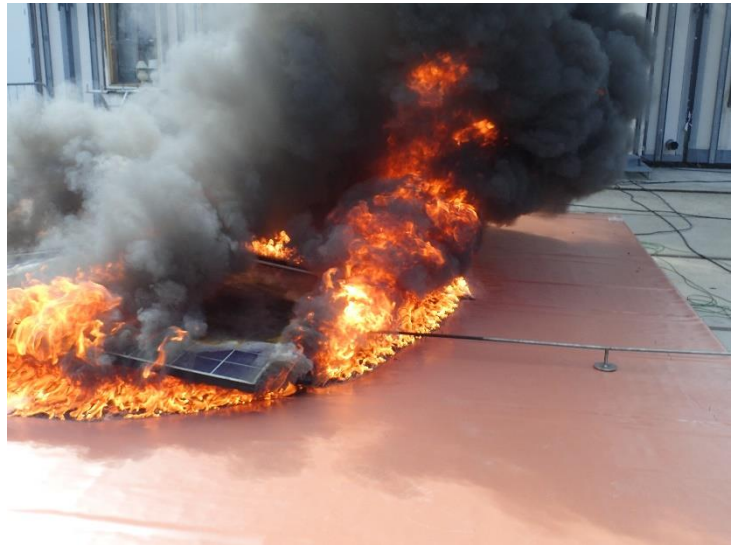
Photo 29

The fire is spreading backwards and on the left side, outside the PV modules (time 15:08).

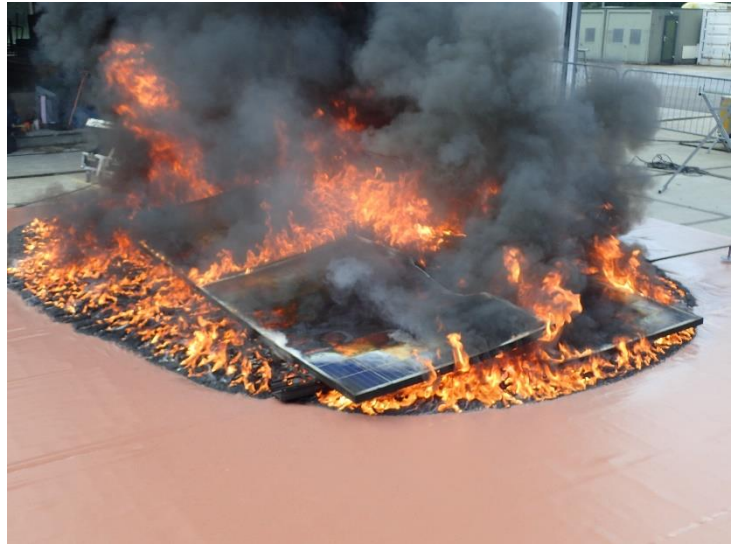
Photo 30

The fire is spreading forwards, outside the PV modules (15:09).

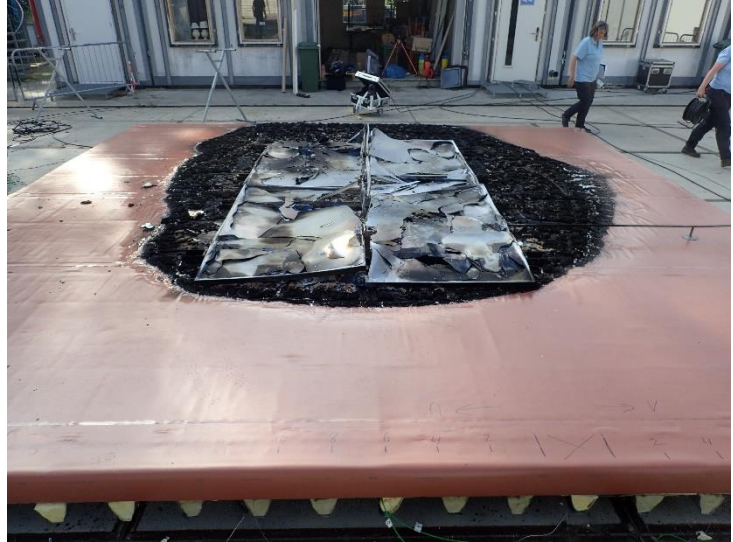
The total burnt area on the roof covering was comparable in both tests. For MW insulated roof the burnt area was slightly larger, but as the direction of flame spread on the PIR insulated roof was different, the fire reached the edge of the specimen on one side – therefore it can be assumed that the burnt area would have been larger if the distance from the PV panel array to the edge would have been the same as on the long side of the PV array.

Photo 32
Overview of the burnt roof
waterproofing sheet including
PV modules.

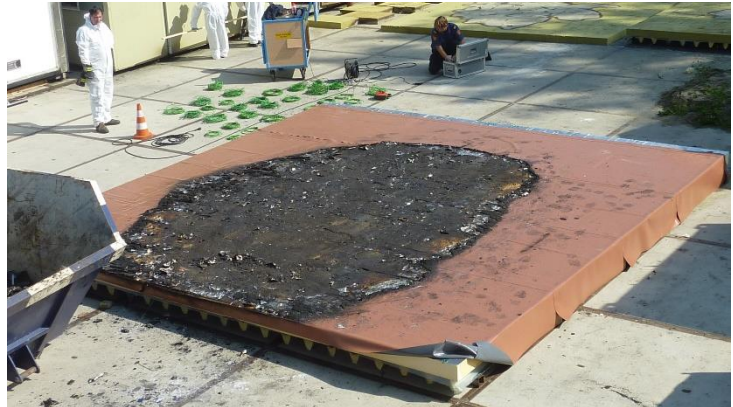
Photo 33
Overview of the burnt roof
waterproofing sheet.

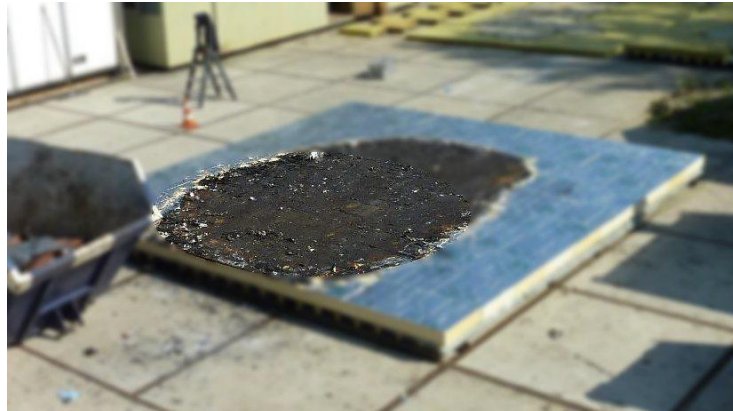
In test specimen B (PIR) the fire has gone out after 32:27 (min:s). After 23 minutes the temperature has reached 155 °C in the middle of the insulation, after this time the temperature is decreasing. After approximately 2 hours the highest temperature is 65 °C. After these two hours temperatures are decreasing further until they reached the ambient level again.

Photo 34
Overview of the burnt
insulation.

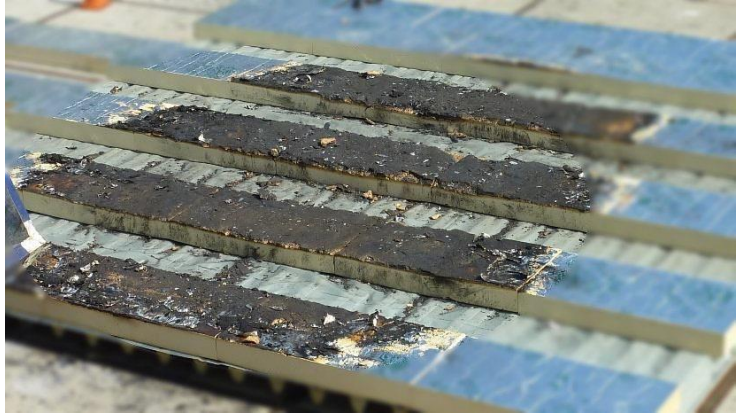
Photo 35
Overview of the burnt
insulation and undamaged
vapour barrier.
