Fire performance of thermal insulation products in end-use conditions

Comparative fire tests to investigate the contribution of PIR & MW thermal insulation products to the fire performance of flat roofs under PV systems

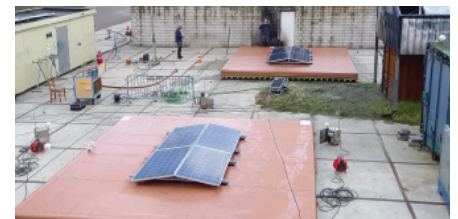
Figure 2: Arrangement of PV system on the roof

with foil back sheets rated fire class C according to IEC 61730-2 [6]. Four of those panels (total size 3.2 m x 1.84 m, angle to roof 13°) were mounted in a back-to-back configuration, which mimics the east-west

configuration which is increasingly used in Northern and Western Europe. In order to have a more critical scenario for possible fire spread, there were no vertical shields at the open ends of the PV array.

The assemblies comprised a waterproofing membrane (PVC), an insulation layer, a vapour barrier (PE foil) and a supporting steel roof deck. The thicknesses of the two insulants were such that the roof assemblies were thermally equivalent (PIR insulation: one layer, 142 mm; MW insulation: 2 layers of 130 mm – total thickness 260 mm).

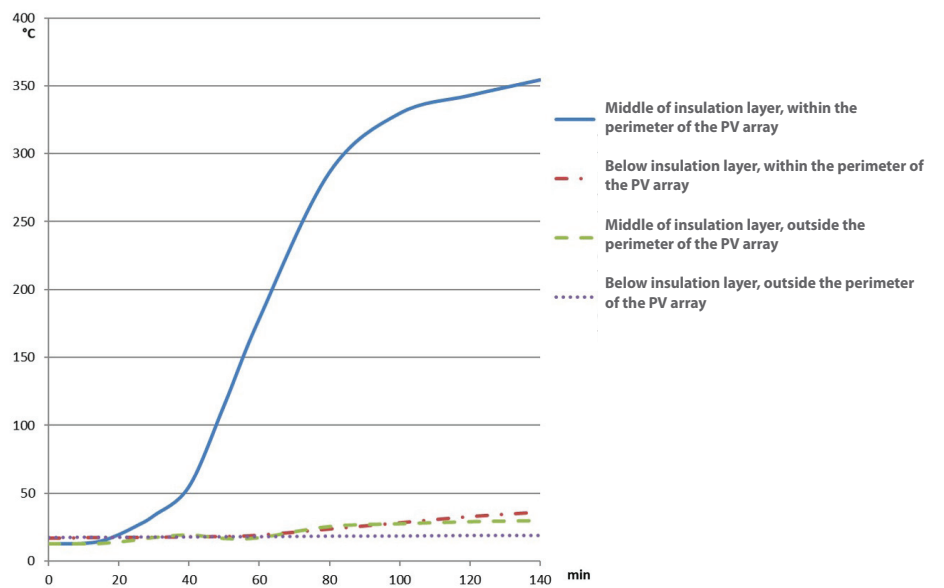
For the roof assembly with PIR, within the perimeter of the PV system, the temperatures in the middle of the insulation layer reached 155°C after 23 minutes and started to decrease after this time. On the steel deck, below the insulation layer, within the perimeter of the PV system, only a slight increase (by 10°C) could be observed up to 80 min after the start of the test. The complete roof including the steel deck started cooling down about 80 min after the start of the test.

For the MW insulated roof, within the perimeter of the PV system, the temperature in the middle of the insulation layer reached 35°C 30 minutes after the

start of the test. Though visible flaming had ceased about 30 min after the start of the test, the temperature reached 290°C after 80 minutes and was increasing further. The maximum temperature recorded was

440°C after 4 hours within the perimeter of the PV system. Overnight measurements on the steel deck showed a peak temperature of 190°C.

Figure 4: Maximum temperatures in °C measured after the start of the tests
